PUBLIC PROPERTY & HEALTH COMMITTEE

Re: Property Maintenance
410 S. Bridge St
City of Markesan, Wisconsin

Wilsnack Condition Assessment

Re: Condition Assessment: 650 N. Margaret Street, Markesan, WI. Tax I.D. #251-00406-0000

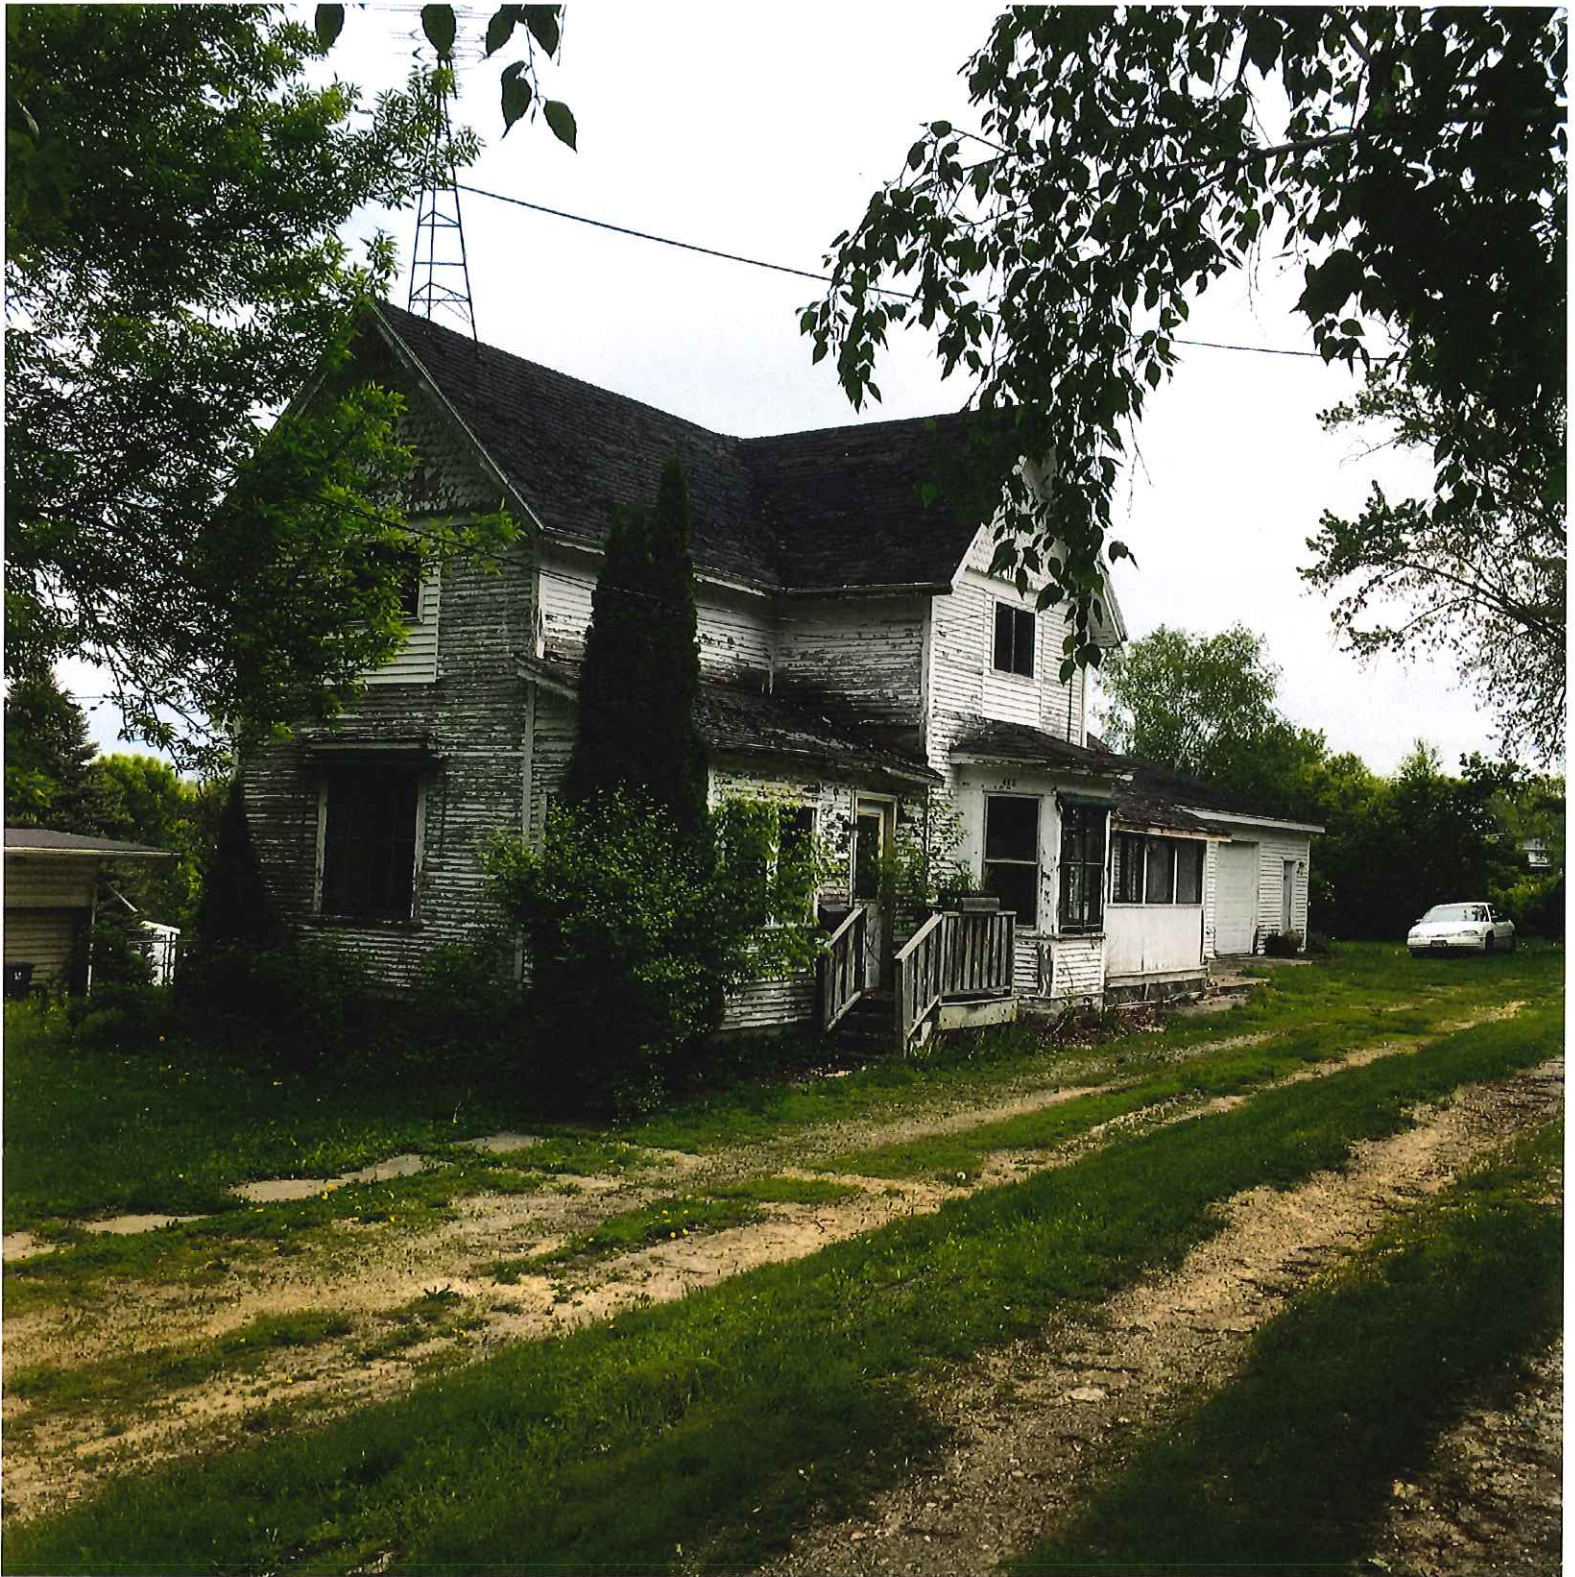
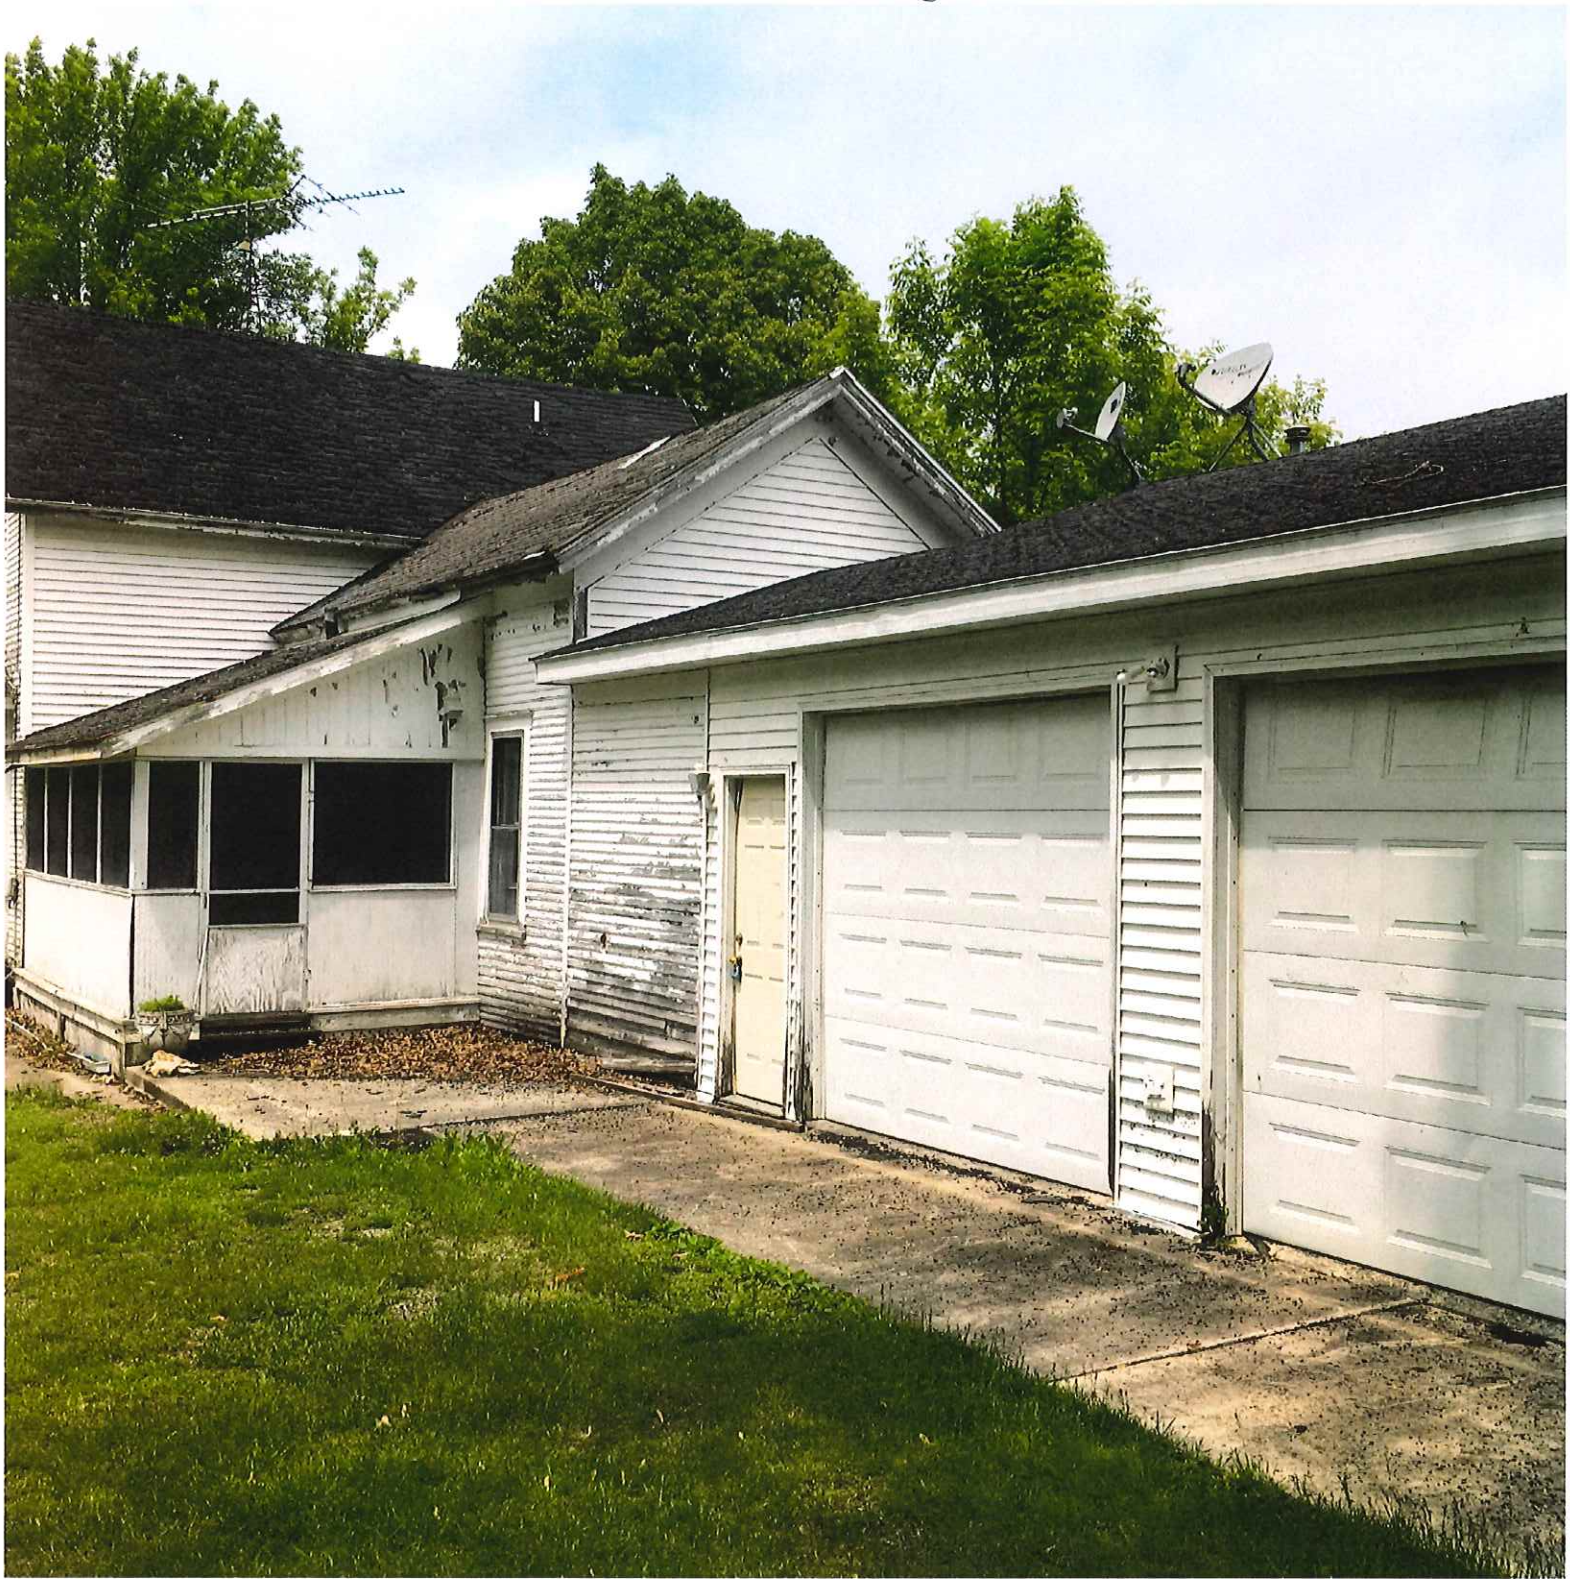
410 S. Bridge St

1. 273-5 D: The exterior appearance of the dwelling does not reflect a level of maintenance consistent with the standards of the neighborhood.
2. 273-5 K: Excessive paint peeling, broken and loose shingles and other conditions that reflect deterioration. The dwelling is not being kept in good repair
3. 273-5 L: Evident water leakage. The dwelling is to be kept weather-tight to prevent structural damage and to avoid safety, health and fire hazards.

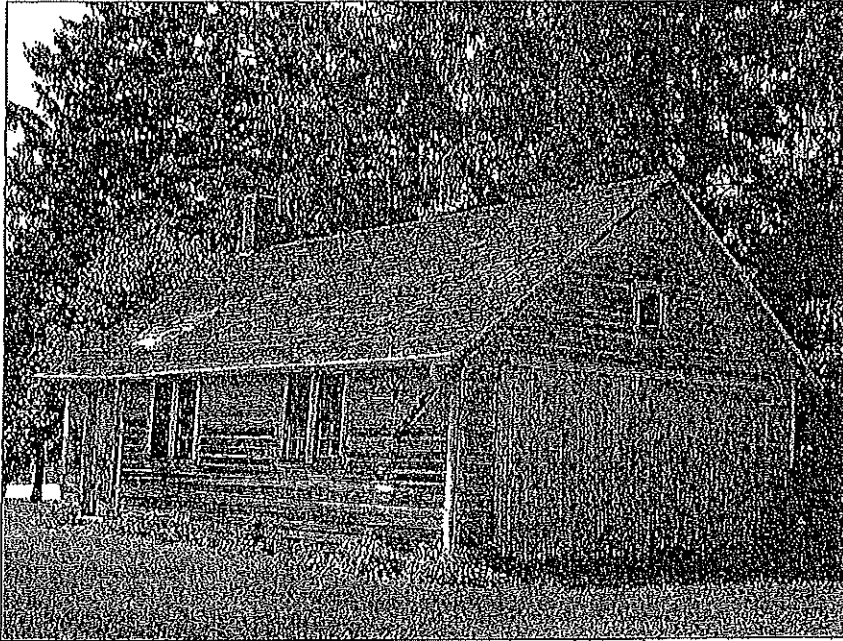
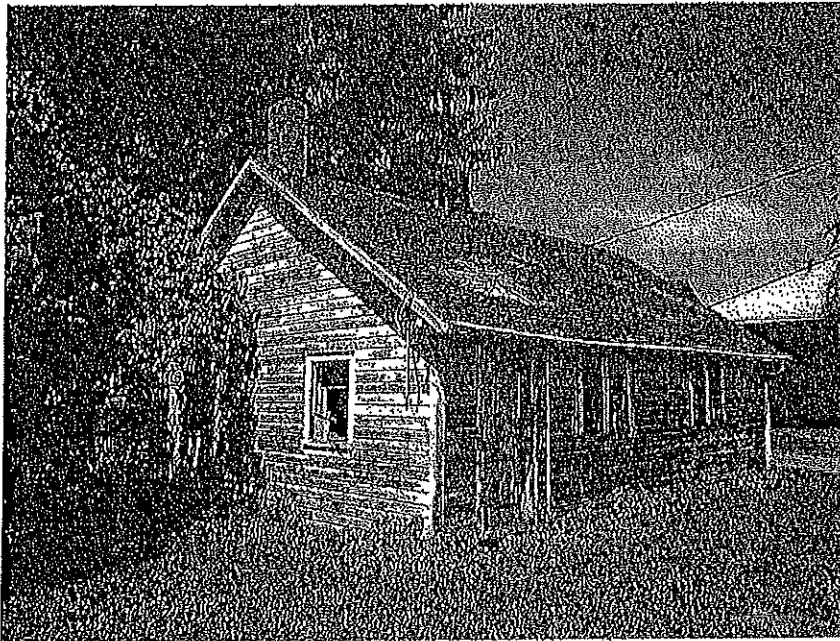
BUILDING #1

- 2.1.1 Building #1 is a detached garage which was previously found to be in only Fair Condition.
- 2.1.2 No improvements were observed to have been completed since the 2018 inspection. The building as a whole has continued to deteriorate. The roof sustained the most notable deterioration with significant shingle loss. Multiple holes were observed to have developed in the roof as well.
- 2.1.3 The observed condition of Building #1 has been downgraded to Poor Condition.

The City of Markesan orders you, as owner of the following described property, to raze buildings 1, 2, 3, 5, 6, 7, 8, 9 and 11 as shown on the attached pictures from General Engineering Company property condition assessment dated July, 2018, located at 650 N. Margaret Street, Markesan, Wisconsin, 53946:

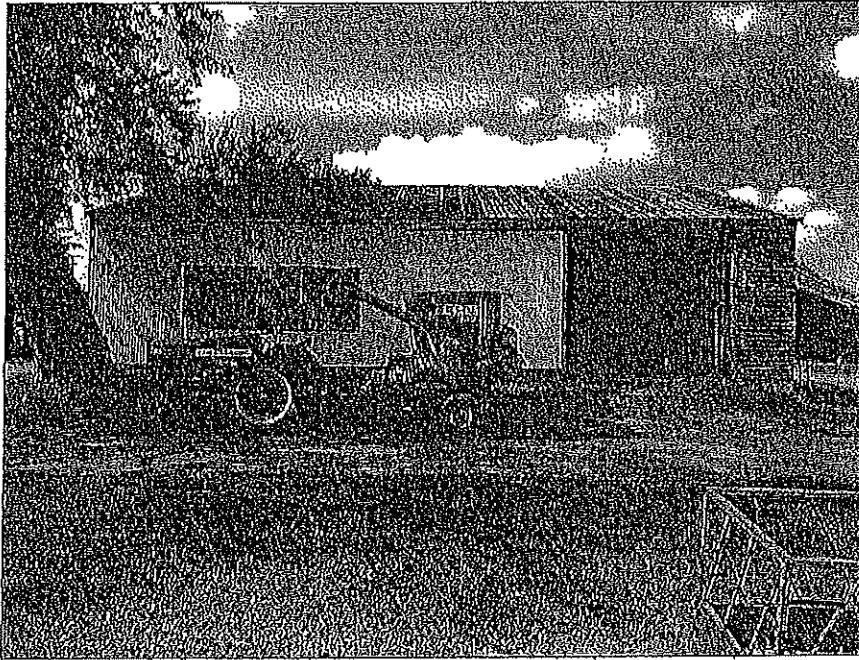
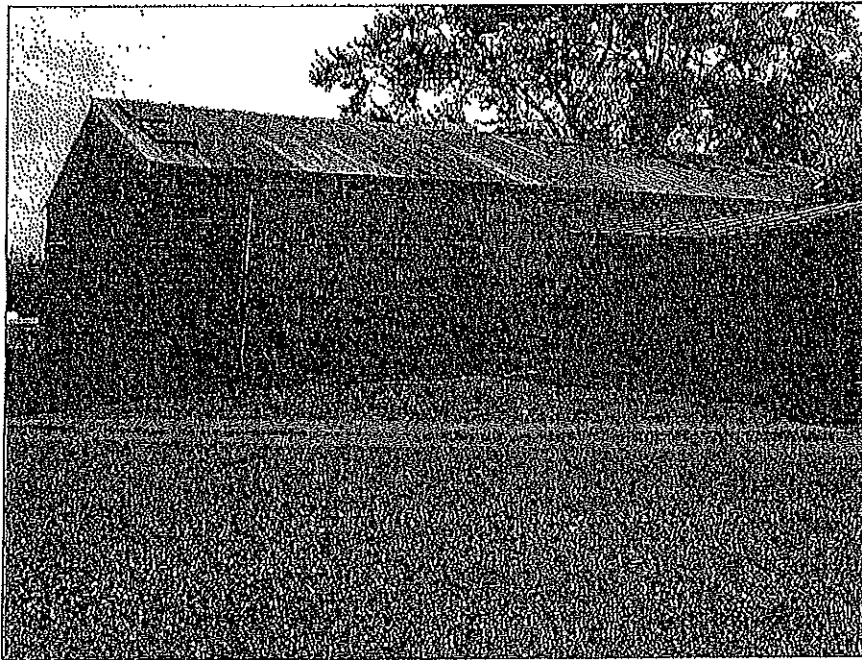
BUILDING #2

- 2.2.1 The construction type of Building #2 is commonly referred to as a pole shed.
- 2.2.2 No improvements were observed to have been completed since the 2018 inspection. The building as a whole has continued to deteriorate.
- 2.2.3 Since the last inspection, structural damage to two (2) roof trusses has occurred. These trusses are located at the SE corner of the building. Damage appears to have occurred while loading large square bales of hay into the building.
- 2.2.4 As a result of the structural damage, the condition of Building #2 has been downgraded from Fair to Poor Condition overall.

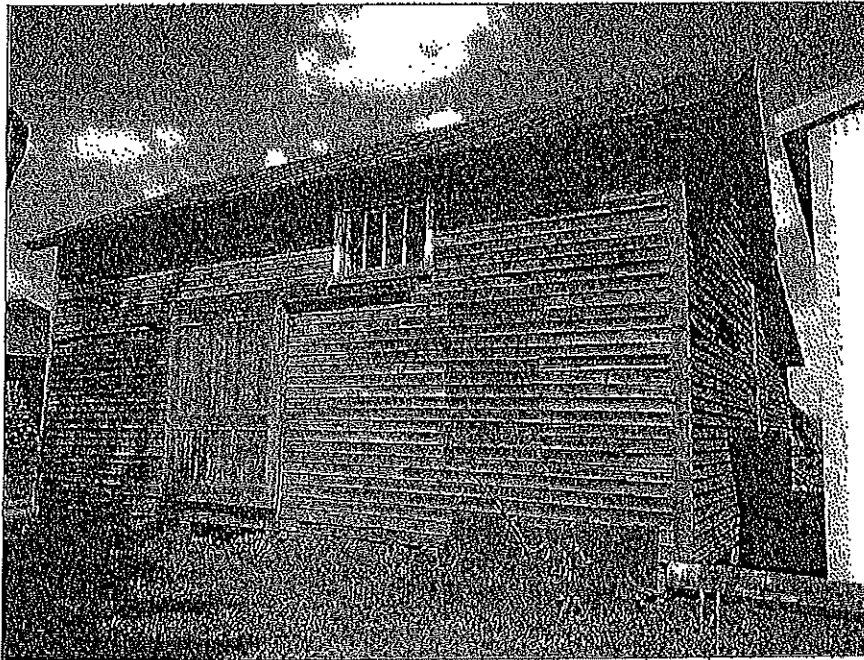
BUILDING #3

- 2.3.1 Building #3 is a wooden framed building with an open lean-to. The structure is clad in wooden lap style siding, and a combination of wooden shake shingles and standing seam steel roofing.
- 2.3.2 No improvements were observed to have been completed since the 2018 inspection. The building as a whole has continued to deteriorate.
- 2.3.3 As a result of the continued deterioration Building #3 has been downgraded from Fair to Poor overall condition.

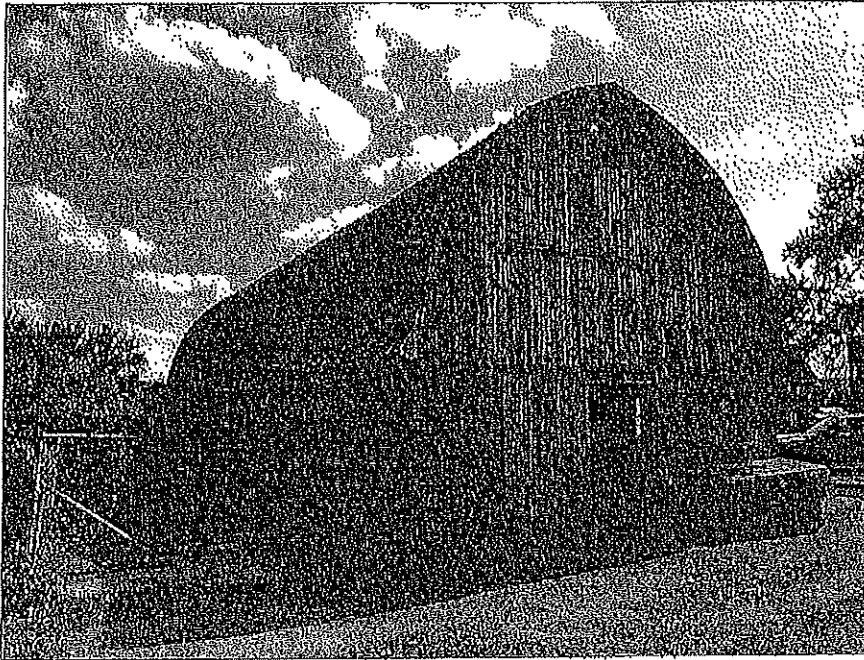
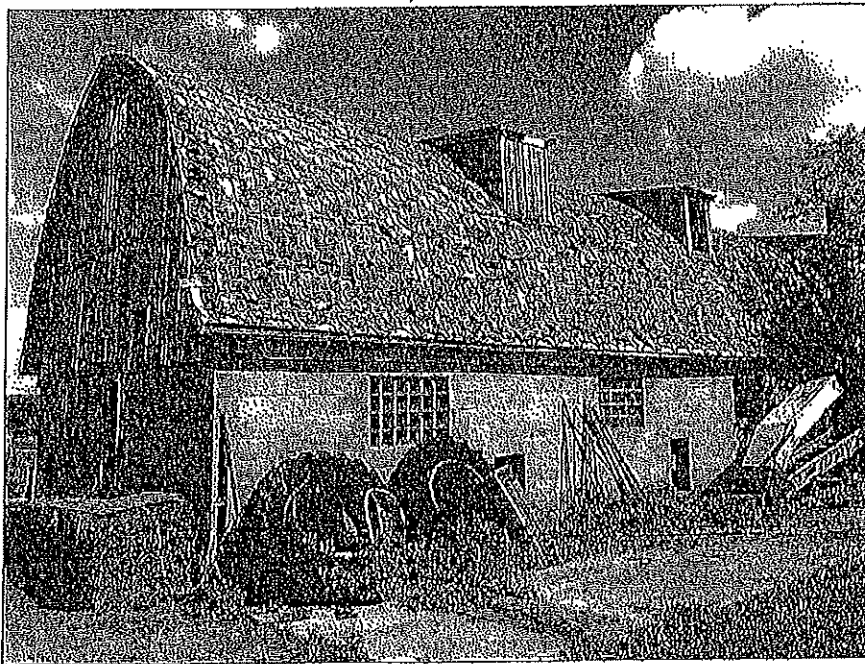
BUILDING #5

- 2.5.2 No improvements were observed to have been completed since the 2018 inspection and the building was observed to have continued to deteriorate.
- 2.5.3 Significant shingle loss has resulted in an actively leaking roof which has consequently resulted in rotting of not only roof framing members, but it has compromised loft floor support beams. Additionally, advanced foundational issues were observed at the south end of Building #5.
- 2.5.4 The condition of Building #5 has been downgraded from Fair to Poor Condition overall. The building was found to be old, dilapidated and out repair so as to be dangerous, unsafe and unfit for human use.

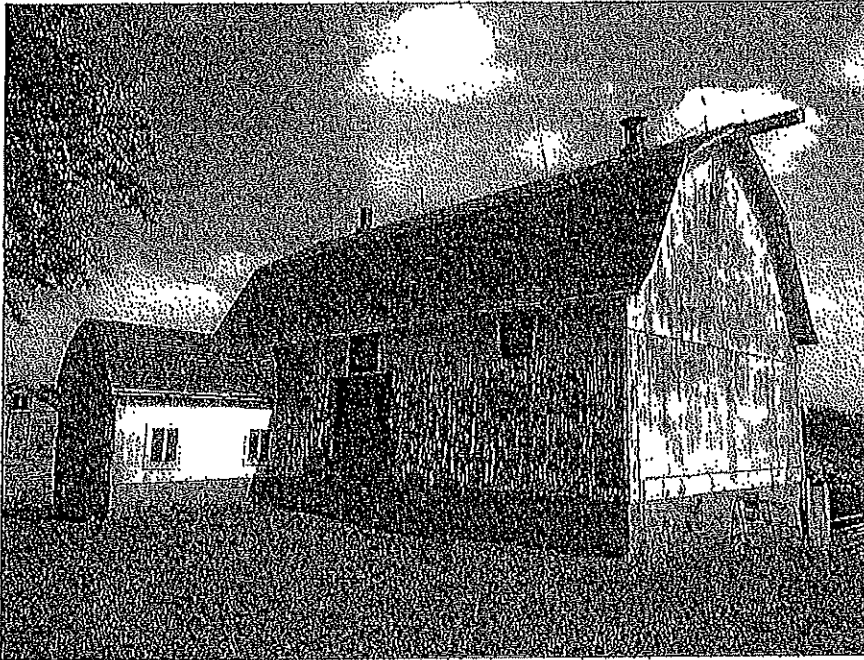
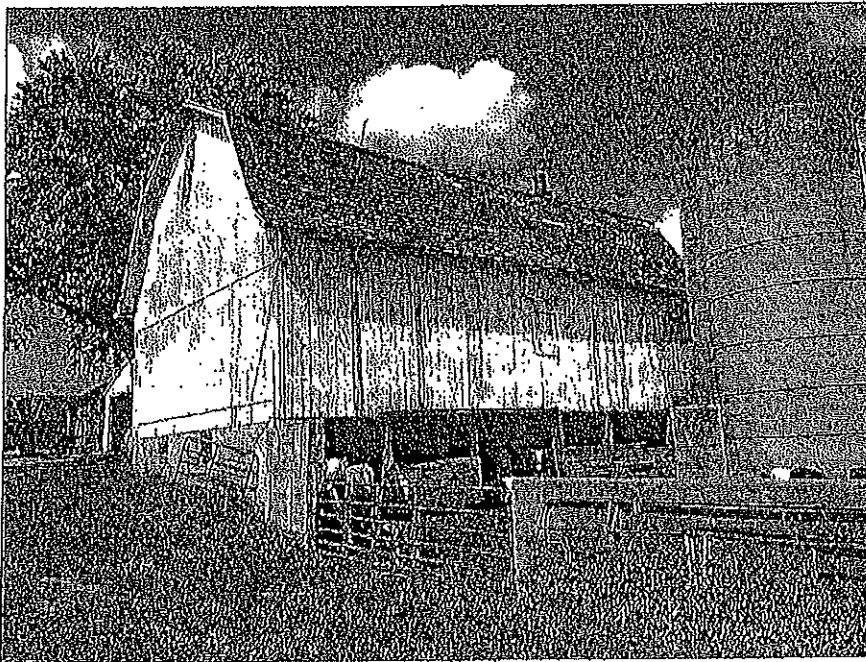
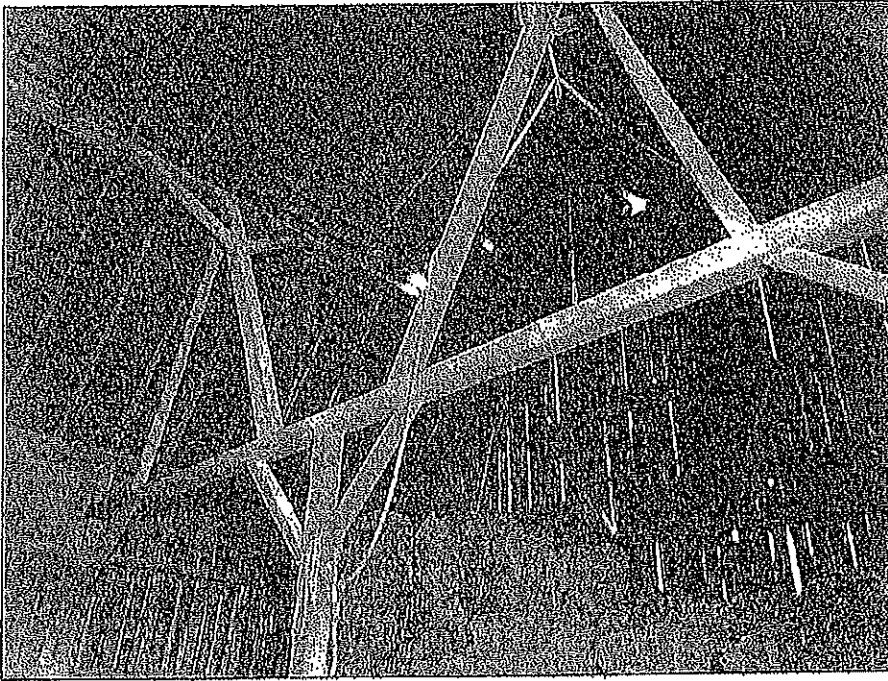
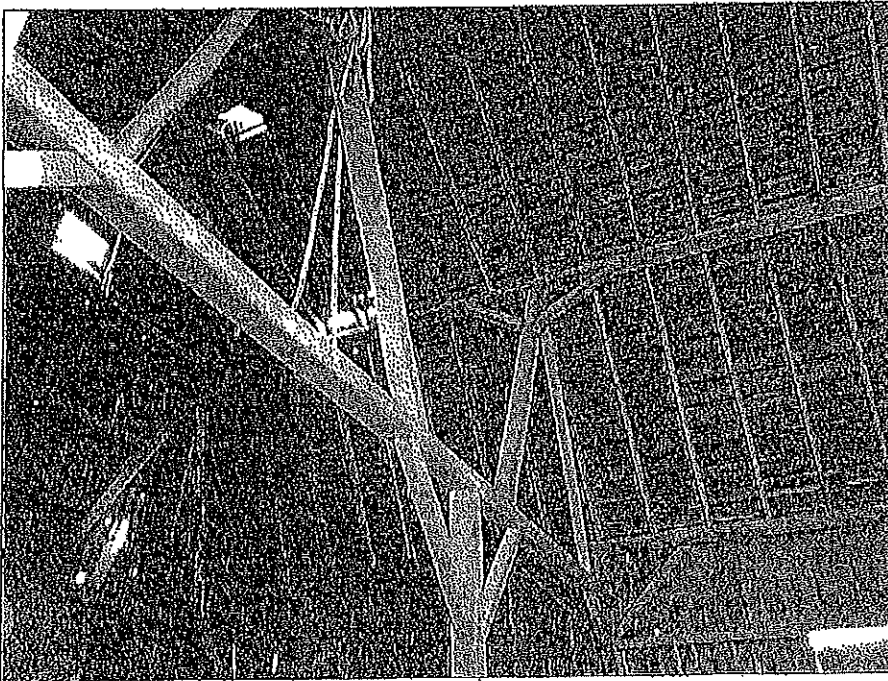
BUILDING #6

- 2.6.1 Building #6 is a traditionally framed post and beam style wooden barn clad in vertical wooden siding and an asphalt shingled roof. The foundation of said structure is primarily a stone masonry type.

- 2.6.2 No improvements were observed to have been completed since the 2018 inspection and the building was observed to have continued to deteriorate.
- 2.6.3 At the time of the last inspection, cattle occupied the lowest level of the barn and as such I was unable to access that area. Upon re-inspection I was able to access the lower area and as such was able to better evaluate the structure.

- 2.6.4 In the 2018 report I called attention to a structural column which appeared to have been removed from the lower area. Upon re-inspection I was able to determine that in fact a wooden support column has been removed. I was also able to determine that this column not only supported the loft area directly above it, but it also supported a portion of the roof load. In light of the evidence, I consider the missing support column to be a significant structural deficiency which has a high potential to lead to at least a partial collapse of the building.

- 2.6.5 In addition to the structural ramifications of the removed support column, I observed other structural members to have been compromised by various means including but not limited to damage from machinery and repeated water infiltration resulting in rot.

- 2.6.6 In light of the newly observed structural deficiencies and continued deterioration of the roof and building as a whole, I have downgraded the condition of Building #6 from Fair to Poor Condition overall. Furthermore, due to the aforementioned structural deficiencies the building is to be considered to be so out repair as to be dangerous, unsafe and unfit for human use.

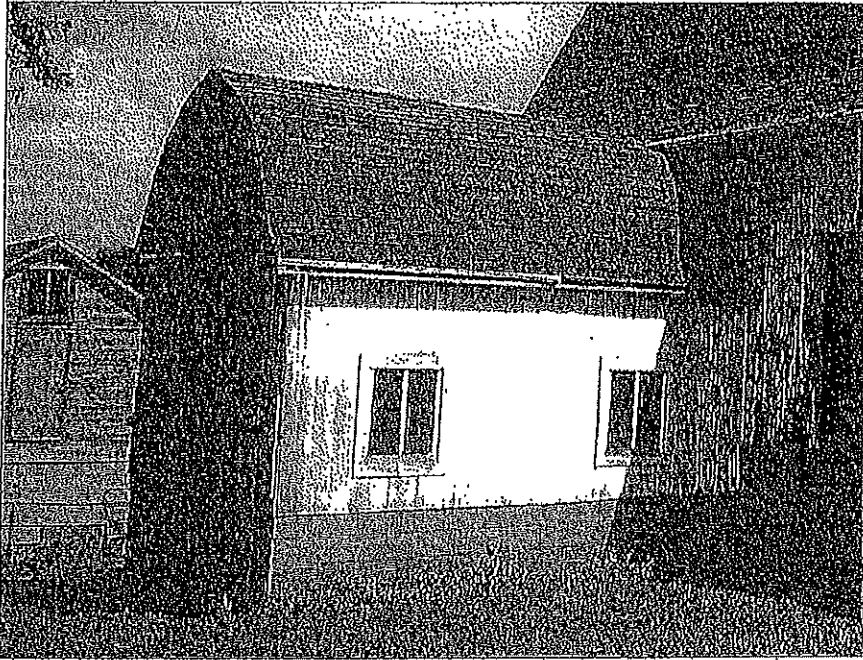
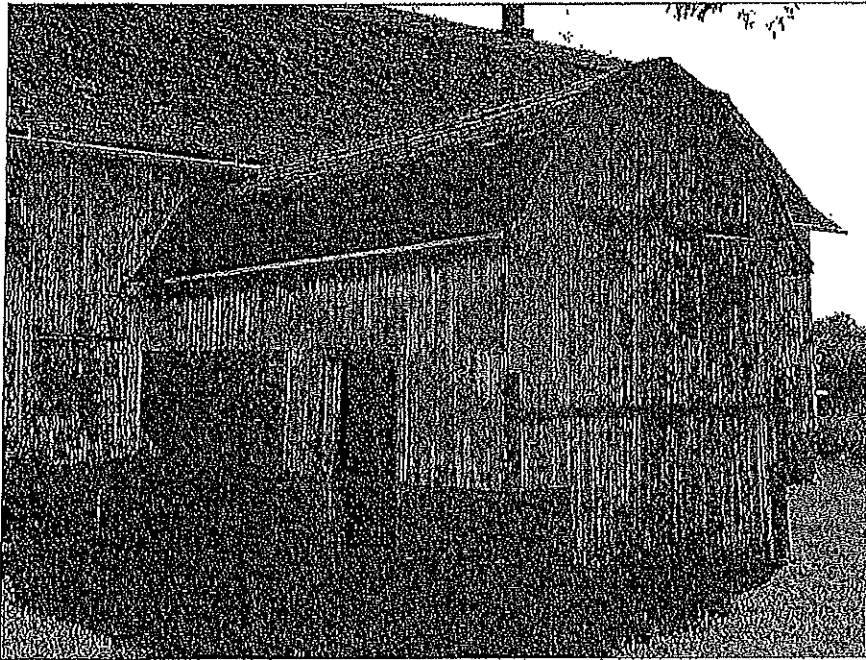
BUILDING #7

- 2.7.1 Building #7 is a wooden framed structure positioned on a concrete block masonry foundation. The building is clad in vertical wooden siding and asphalt shingles.
- 2.7.2 Building #8 is a wooden framed structure positioned on a stone and concrete block masonry foundation. The building is clad in horizontal wooden lap siding and steel standing seam roofing.

2.7.3 No improvements were observed to have been completed to either building since the inspection of 2018 and the buildings were observed to have continued to deteriorate.

2.7.4 The increased deterioration of buildings #7 and #8 combined with the fact that they are joined to the structurally compromised Building #6 has resulted in a downgrade of each building from Fair to Poor condition overall.

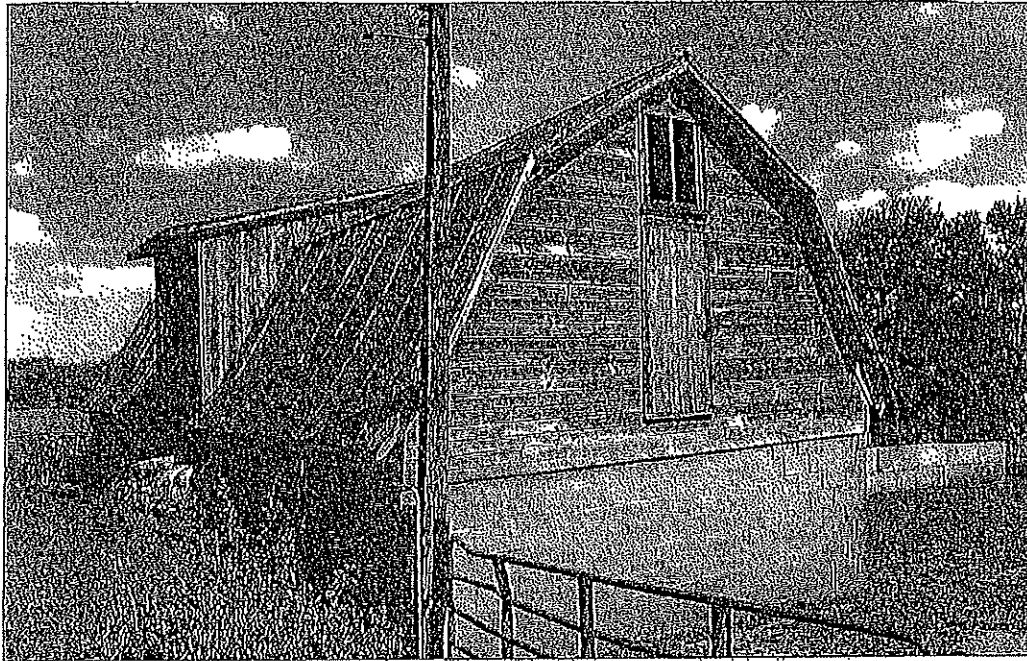
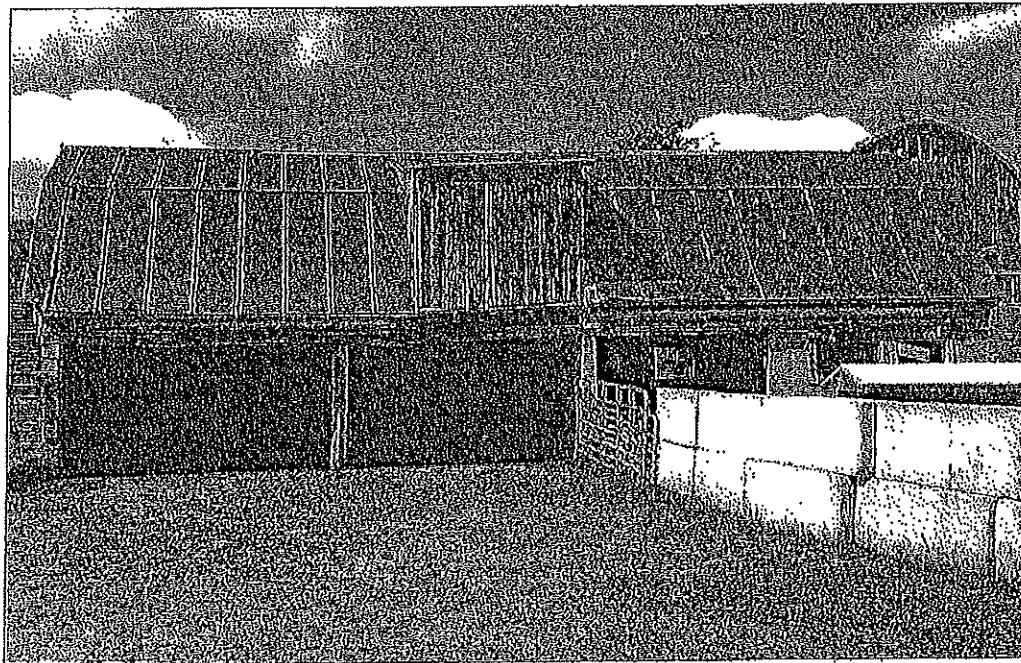
BUILDING #9

2.9.1 Building #9 is a wooden framed structure positioned on a cast-in-place concrete and concrete block masonry foundation. The building is clad in wooden siding and steel standing seam roofing.

2.9.2 No improvements were observed to have been completed to the building since the inspection of 2018 and the building was observed to have continued to deteriorate.

2.9.3 In addition to the general deterioration of the building as a whole, the main support beam and column assemblies for the West approximate half of Building #9 was observed to be significantly compromised. The wooden column and beam, which support both the loft and roof assemblies, were observed to be substantially rotted and to have been knocked out of position to the extent they are in danger of collapse. Should the column and beam collapse, it is likely the West half of the building will collapse.

2.9.4 Due to the newly observed structural deficiencies, Building #9 has been downgraded from Fair to Poor Condition overall. Furthermore, due to the aforementioned structural deficiencies the building is to be considered to be so out repair as to be dangerous, unsafe and unfit for human use.

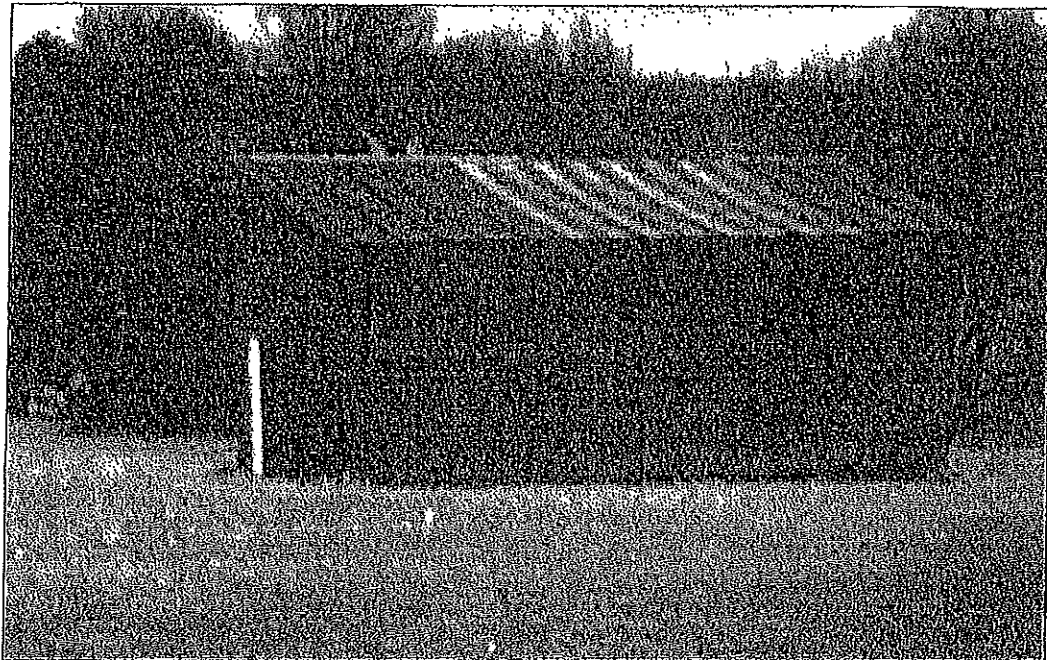
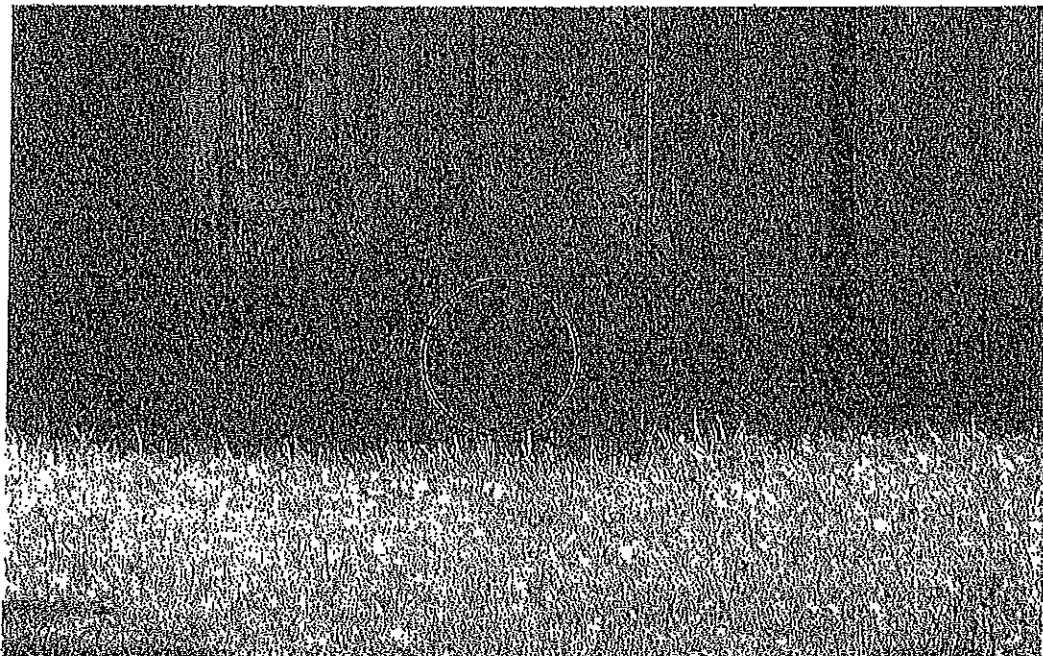
BUILDING #11

2.11.2 No improvements were observed to have been completed to the building since the 2018 inspection.

2.11.3 Holes were observed to be going under the perimeter of the building suggesting that animals are frequenting this area. Additionally, the door to the building was dilapidated leaving the building relatively unsecured.

2.11.4 I would categorize the building as being in only Fair condition.

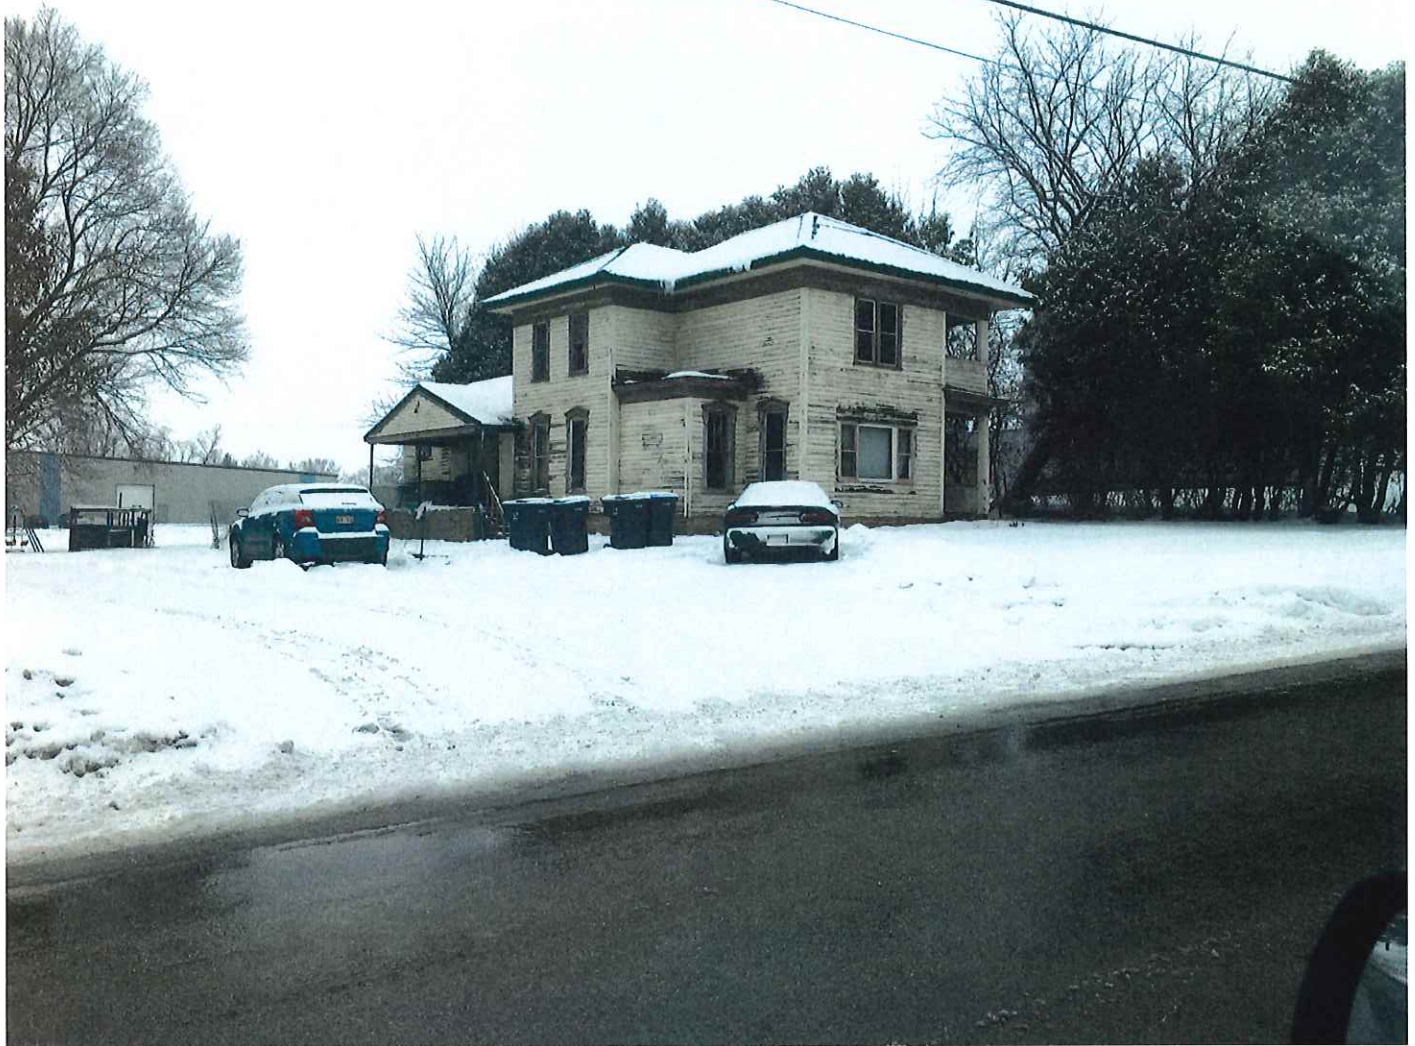
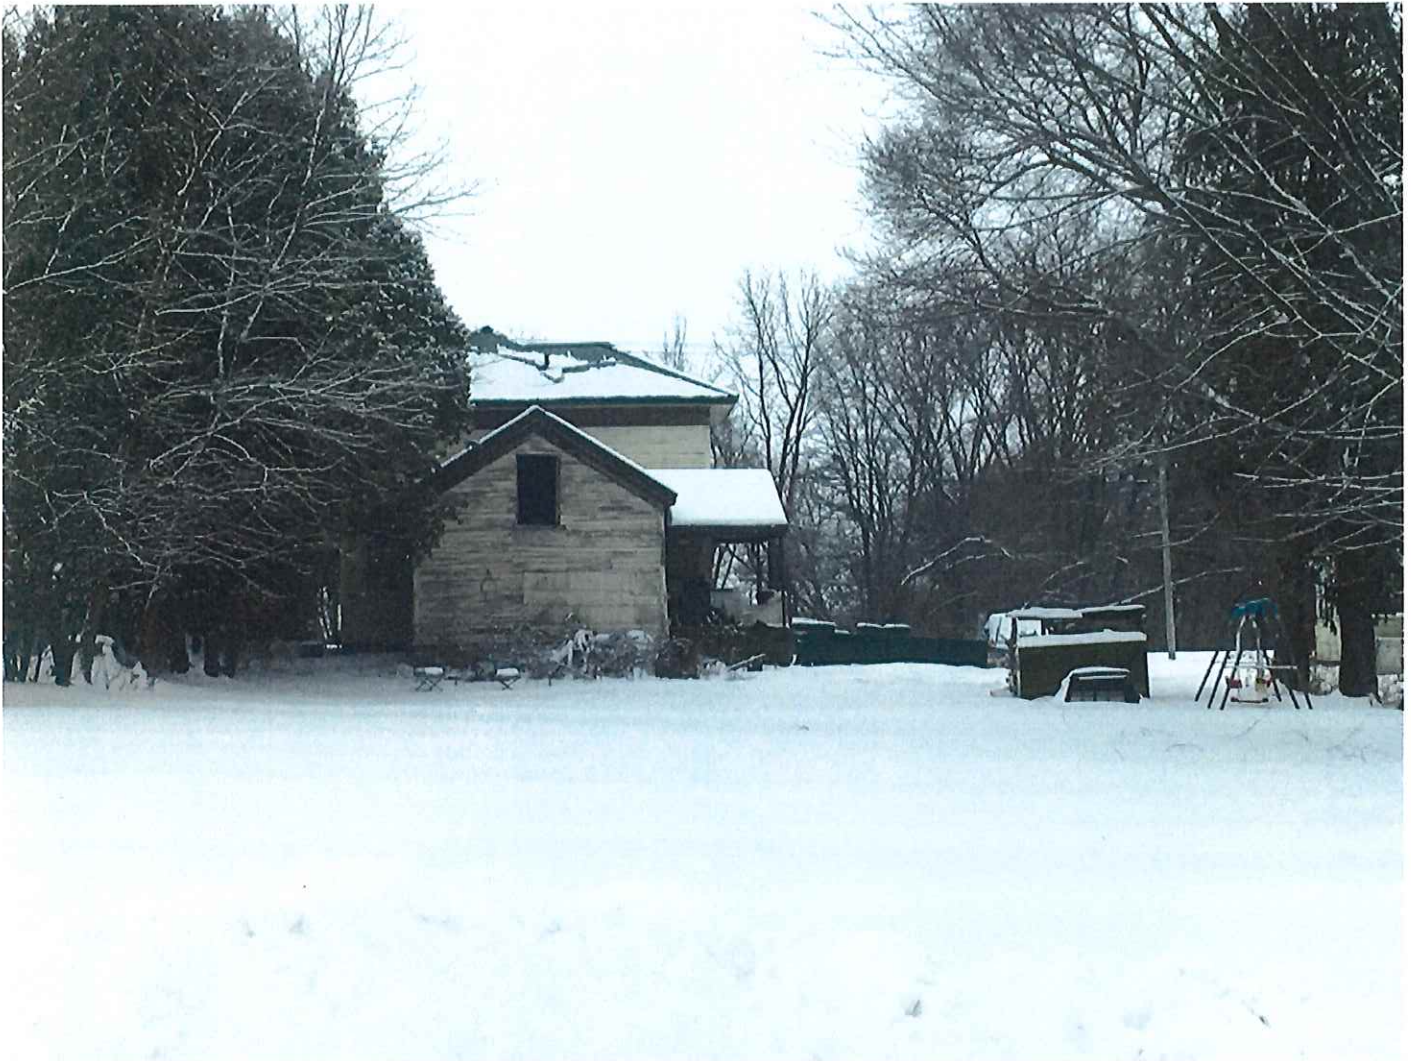
Next are the more expensive, but necessary repairs for the structural integrity of the house. Repair or replace the missing or broken windows. Repair or replace the deteriorated exterior siding. Repairing these 2 items will prevent further structural damage to the house. It is clear from the pictures the front entry porch/2nd floor deck is structurally unsound and needs to be rebuilt. These items will require a permit as well.

The easiest and least expensive repairs are to provide a code compliant guardrail on the rear porch and code compliant steps on the front porch. (Items 1 and 3 in the attached letter.) This would correct the most obvious and immediate health and safety issues. A building permit would be required for this work.
